Monitoring Data RecordProject Title: R-2719A Crescent Road COE Action ID: 200802460WQC Number: 003763Stream Name: UT to Falling CreekCity, County and other Location Information: UT to Falling Creek is located at the intersection of the future Crescent Road and US 70 in Kinston, Lenoir Co.Date Construction Completed: 3/3/11Monitoring Year: (1) of 5Ecoregion: _____ 8 digit HUC unit 03020202

UT to Falling Creek

Year 1 Winter – January 2012

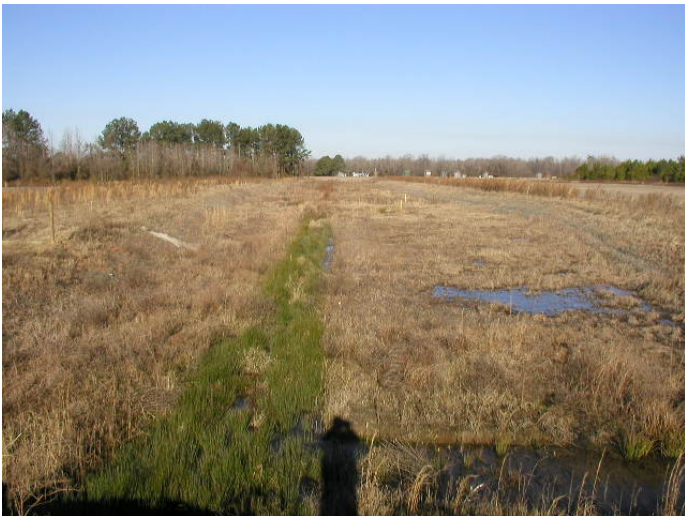
Overview photo looking upstream

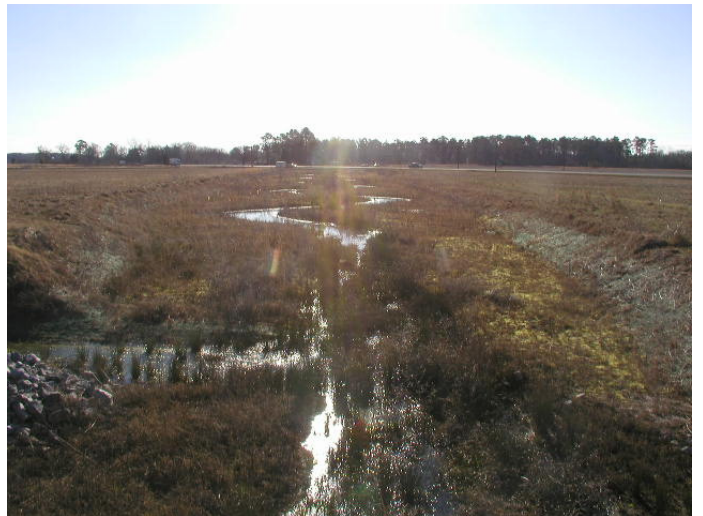
Overview photo looking downstream
